# Manhole Inspection Summary

Manhole # S39AA\_043MH

Insp Date: **11/27/07 12:45 PM**

**Location** Address: **e.monument**

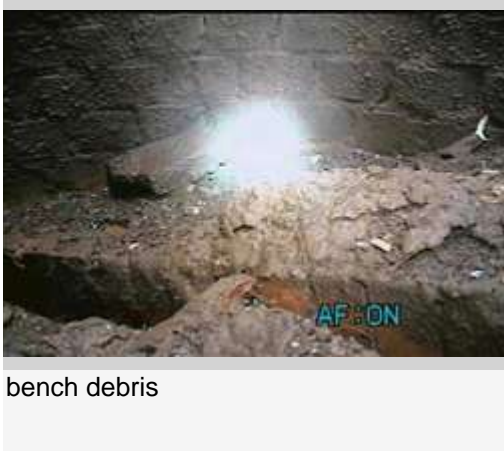
Defect 4

Condition: ☐ Sound ☐ Cracked ☐ Root Intrusion ☐ Deteriorated ☐ Leaks ☒ **Debris**

bench debris

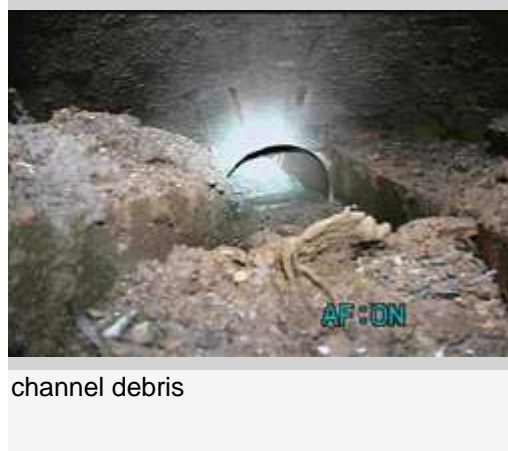
Defect 3

Condition: ☐ Sound ☐ Cracked ☐ Root Intrusion ☐ Deteriorated ☐ Leaks ☒ **Debris**

channel debris

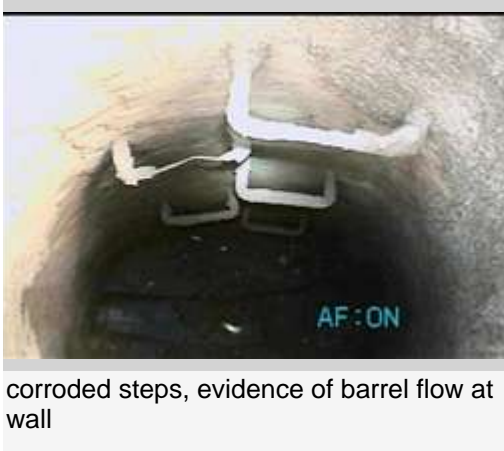
Defect 2

Infiltration: ☐ None ☐ Joint ☐ Cracks ☐ Mortar ☐ Roots ☒ **Wall**

**Steps** Count: **5** Missing: **0** ☒ **Corroded**

corroded steps, evidence of barrel flow at wall

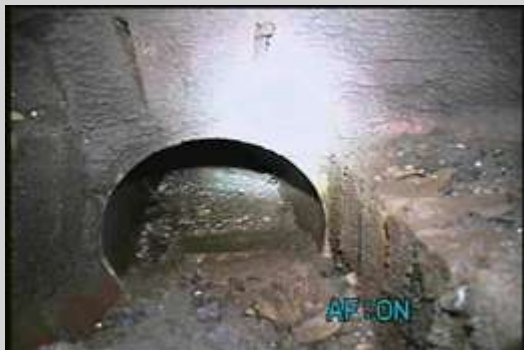
12 O'Clock Outflow

8 in. Circular Gravity Sewer  
Pipe Out @ 12 O'Clock

Invert Depth: 8.75 (ft.) Flow Characteristics: **Slow**

Deposits: ☐ None ☒ **Mud** ☐ Sludge ☐ Debris ☐ Grease

Silt Depth: 3 (in.) Deposits Extent: **Medium**

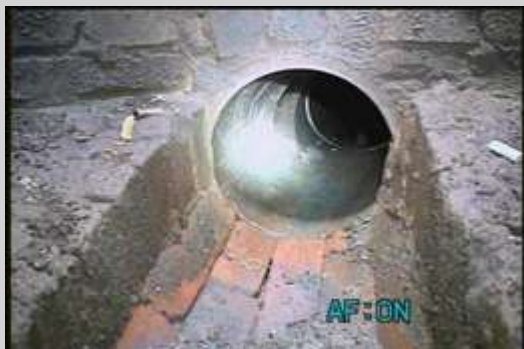
7 O'Clock Inflow

8 in. Circular Gravity Sewer  
Pipe In @ 7 O'Clock

Invert Depth: 9.00 (ft.) Flow Characteristics: **Slow**

Deposits: ☐ None ☒ **Mud** ☐ Sludge ☐ Debris ☐ Grease

Silt Depth: 0 (in.) Deposits Extent: **Medium**
